Sunnyside Coal Mine Community Consultative Committee Meeting #13

Environmental Monitoring Report December 2011 – February 2011

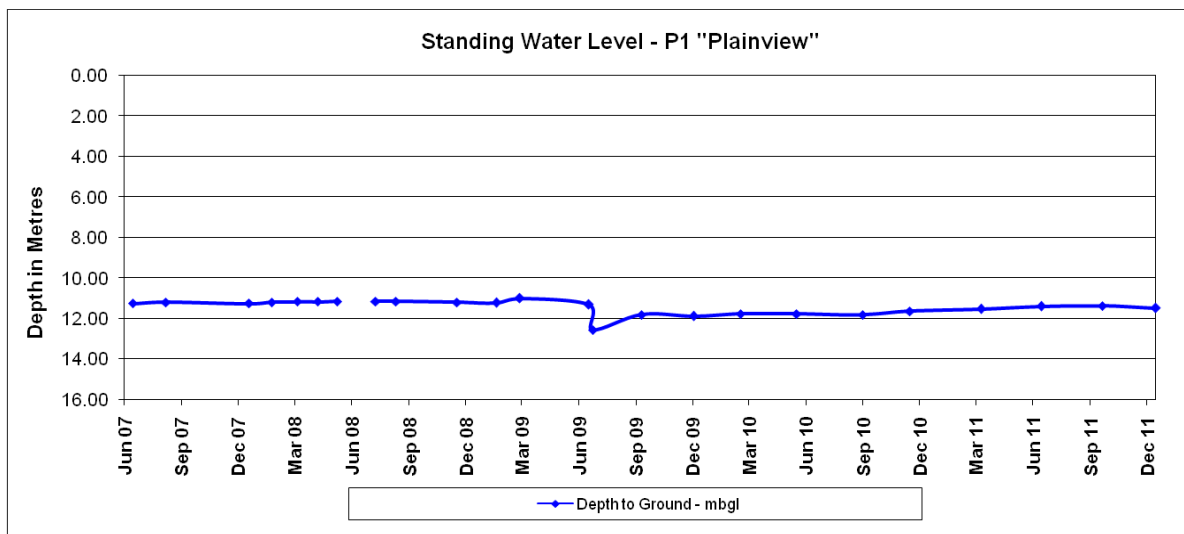
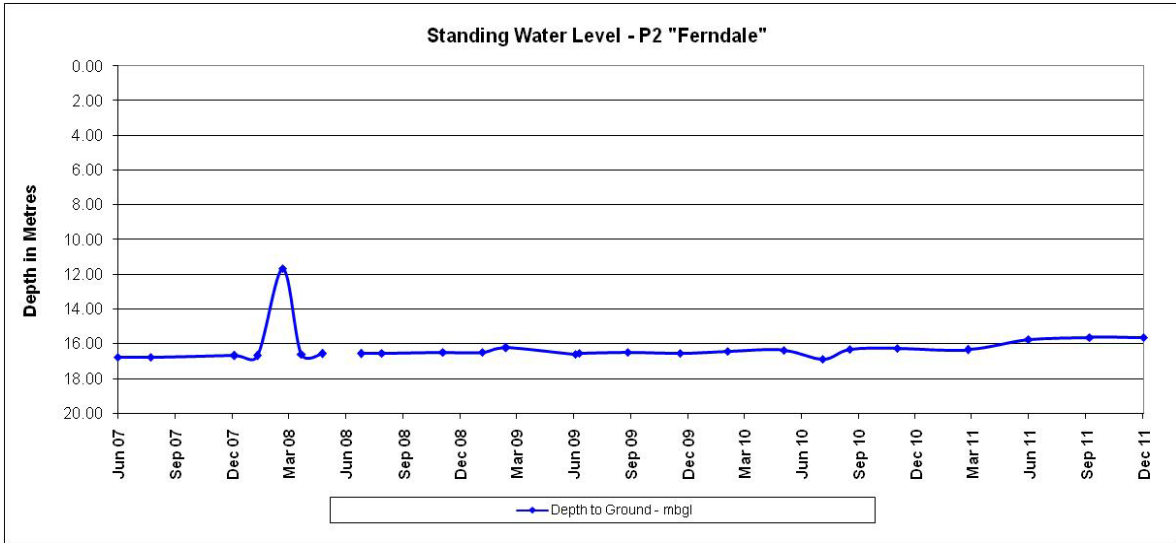
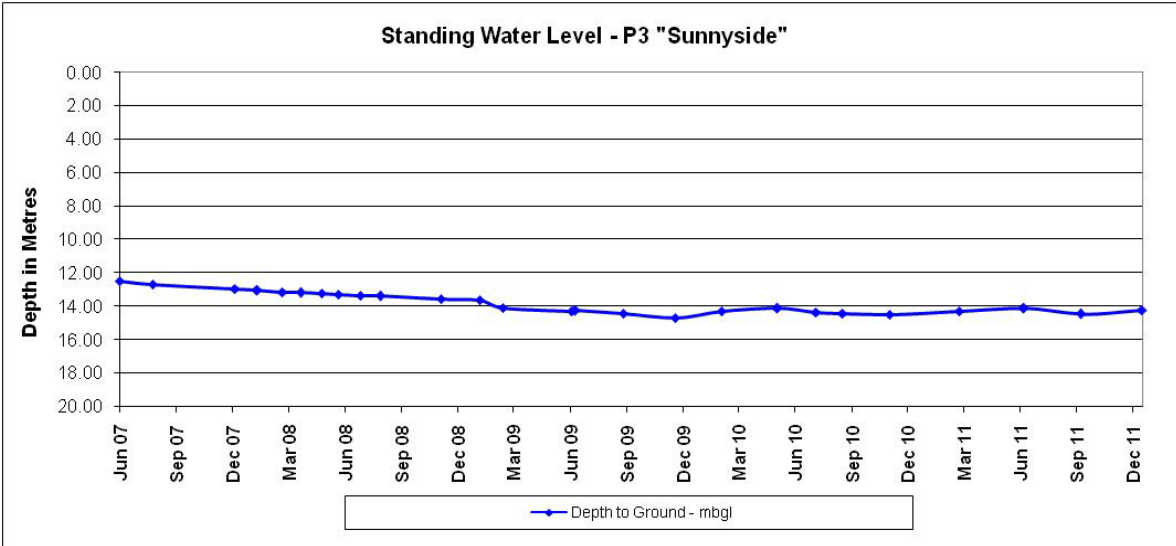
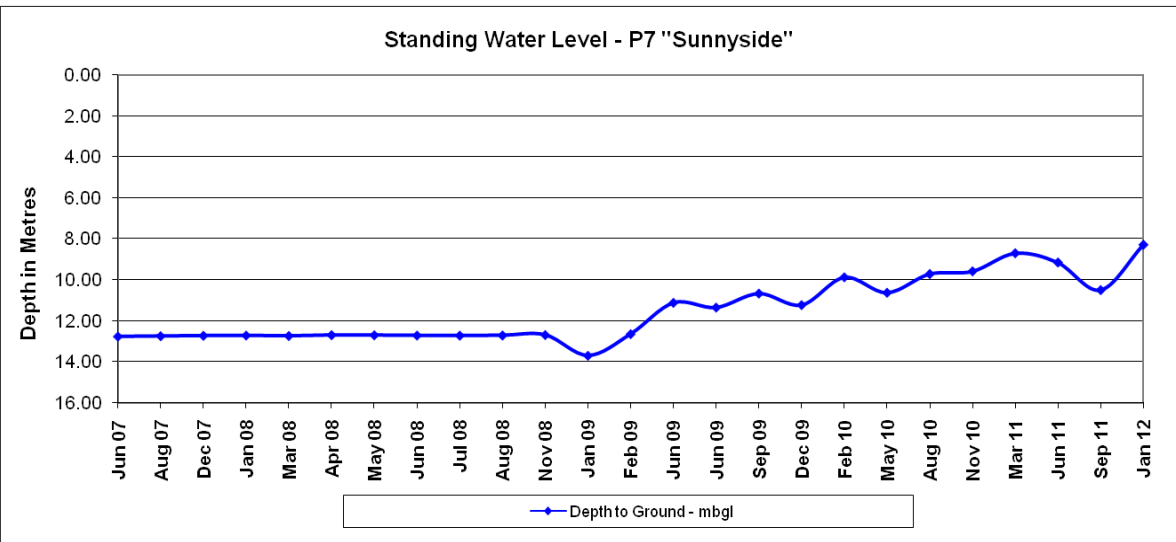
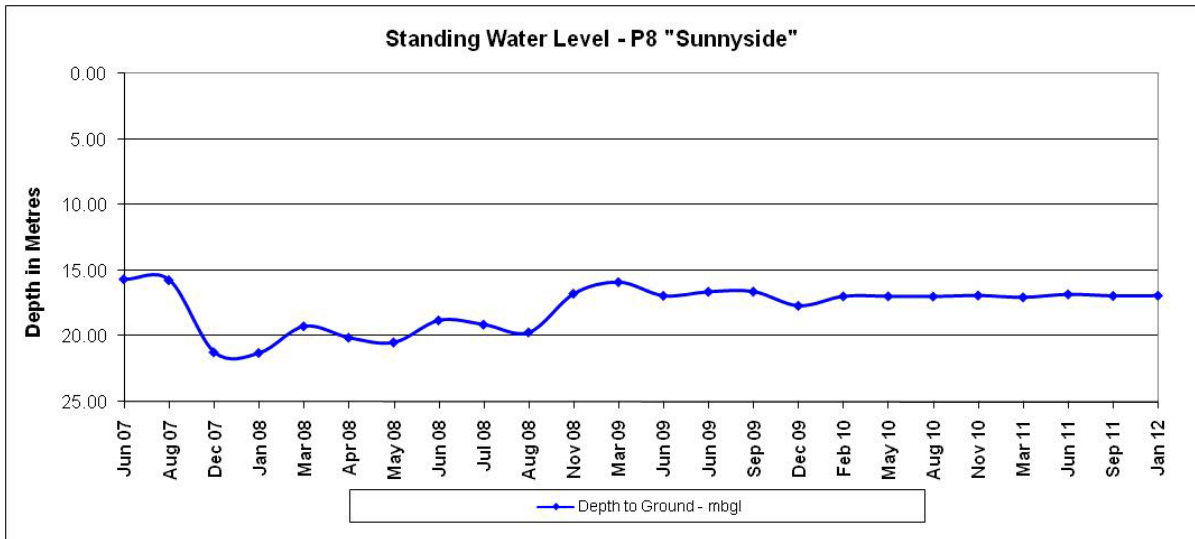
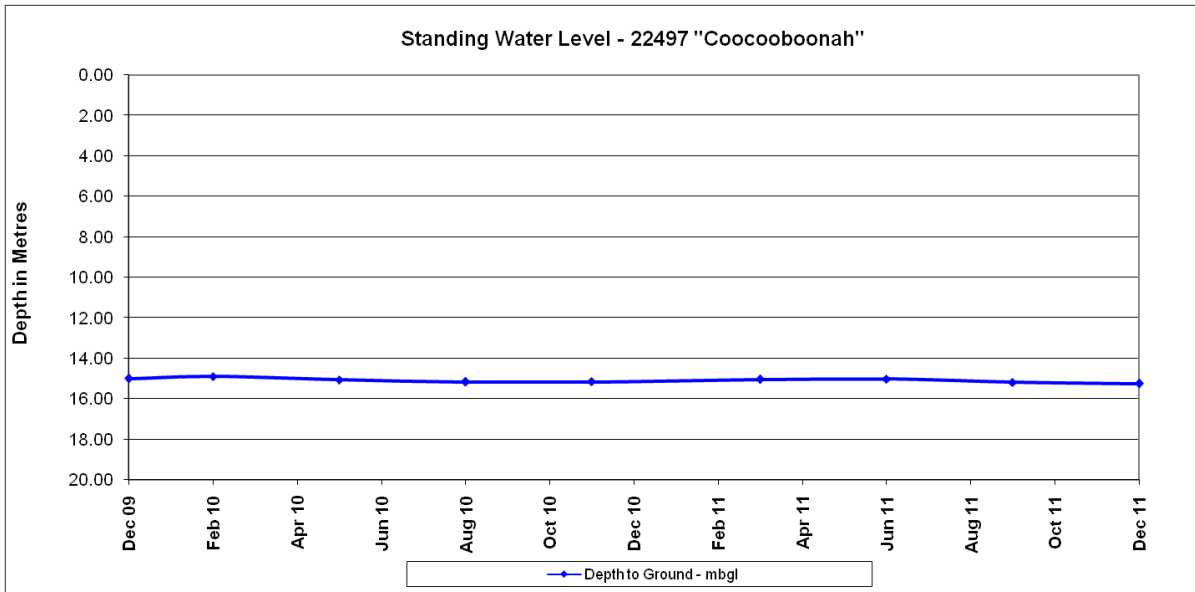
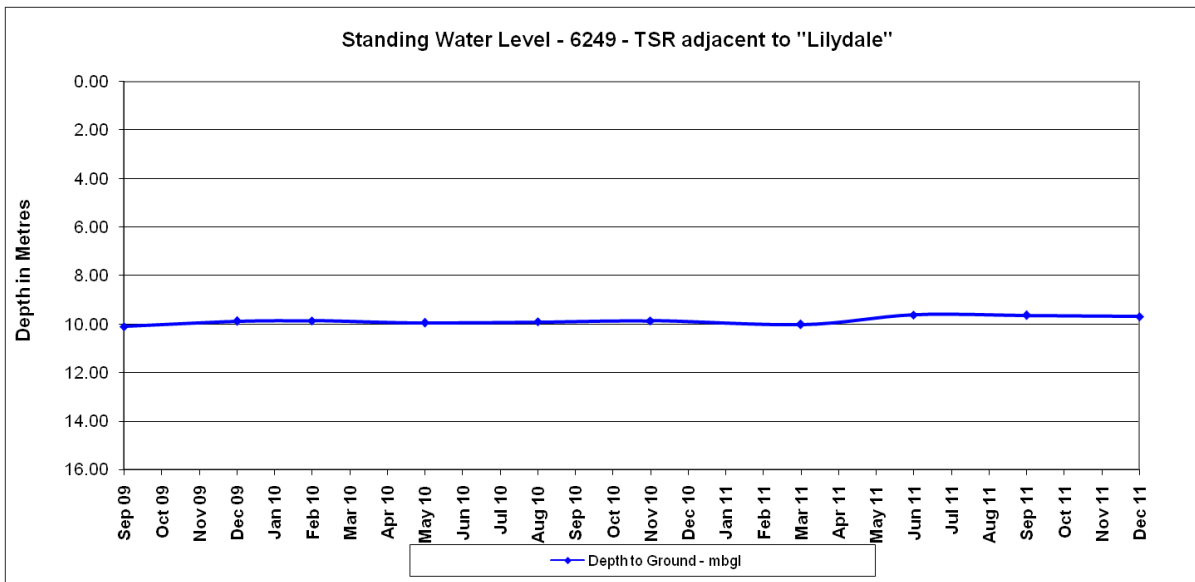
Monitoring was undertaken on the 15th December 2011 and 6th January 2012. Results for SWL are shown below with no significant impact/trend indicated from mining operations, other than at monitoring point P7, where recharge is occurring. This recharge is due to the bore's stand pipe being broken at ground level, accepting inflow from rainfall and as a result recharging. This stand pipe is expected to be repaired in the coming month. These graphs represent water bores and piezometers which are currently accessible for monitoring. Monitoring Piezometer 4 (P4) is now in the production area and will no longer be monitored. The next round of monitoring is expected to be conducted during March 2012.

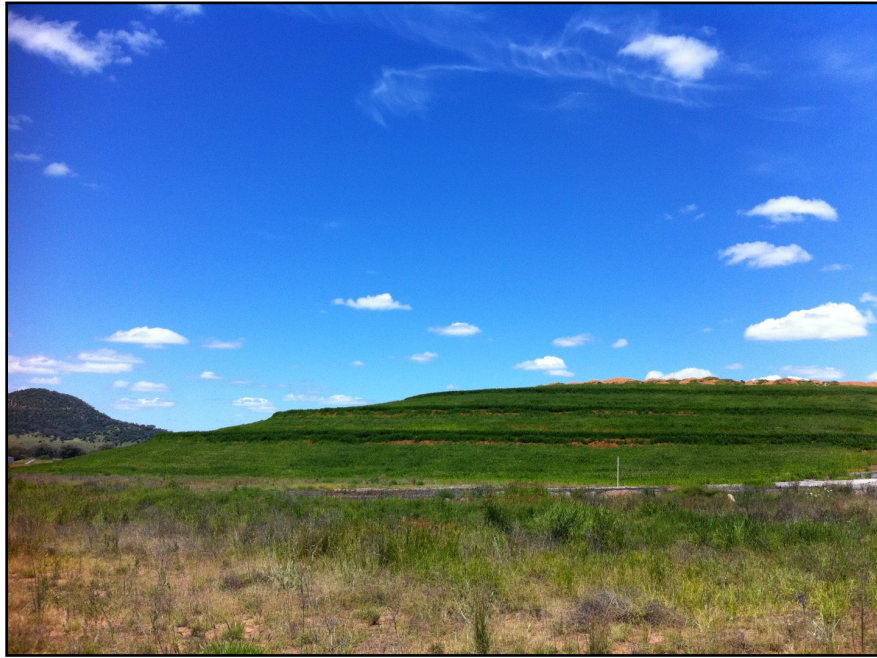
No rehabilitation has occurred since the last CCC meeting. Previous rehabilitation outlined in the last CCC meeting has produced good results.

Developed pasture on newly rehabilitated waste emplacement area
