WHC-PLN-OC-CCL701-Rehabilitation Management Plan

CONSOLIDATED COAL LEASE (CCL) 701 BRICKWORKS, MELVILLE AND SPRINGFIELD REHABILITATION MANAGEMENT PLAN

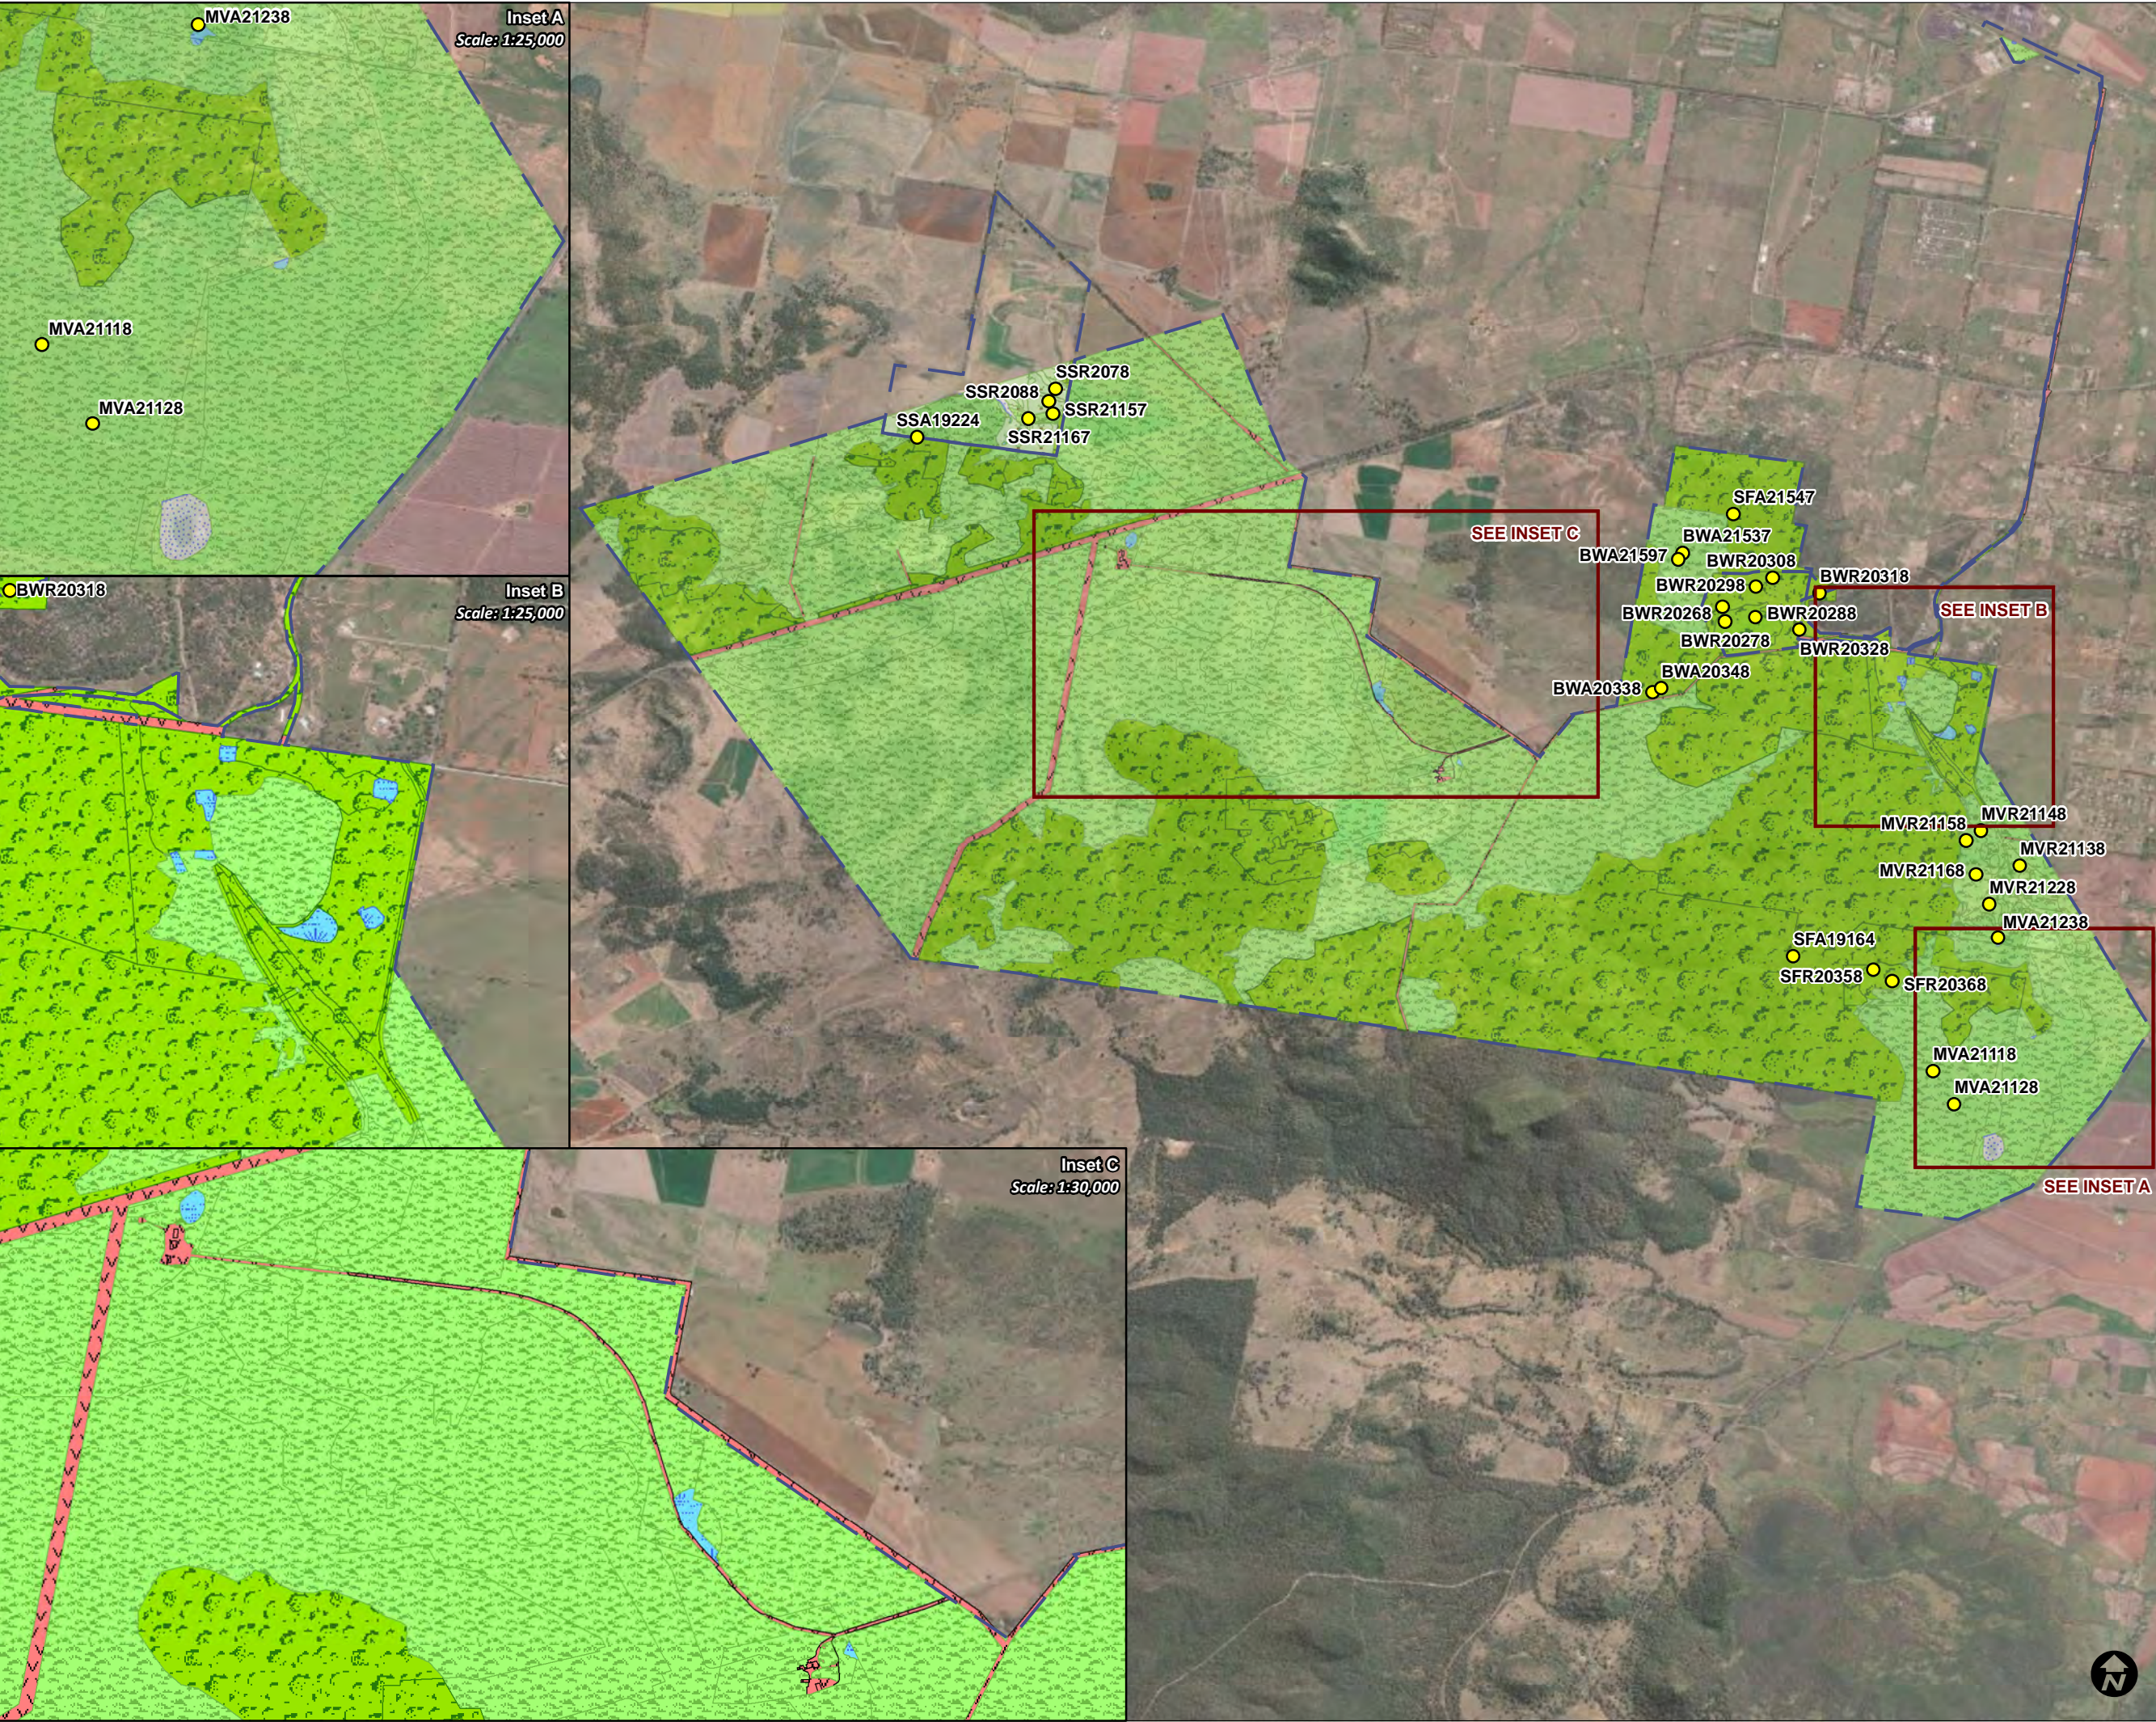
In accordance with the requirements of the *Form and Way: Rehabilitation Management Plan for Large Mines* (RR, 2021a) a *Final Landform and Rehabilitation Plan* has been prepared to show the proposed final land use and final landform of CCL701 sites (refer **Figure 5-1, Figure 5-2, Figure 5-3 and Figure 5-4**).

The final land use domains for this Plan are presented in **Table 2-2** and shown on the Final Landform and Rehabilitation Plans (refer **Figure 5-1, Figure 5-2 and Figure 5-3**).

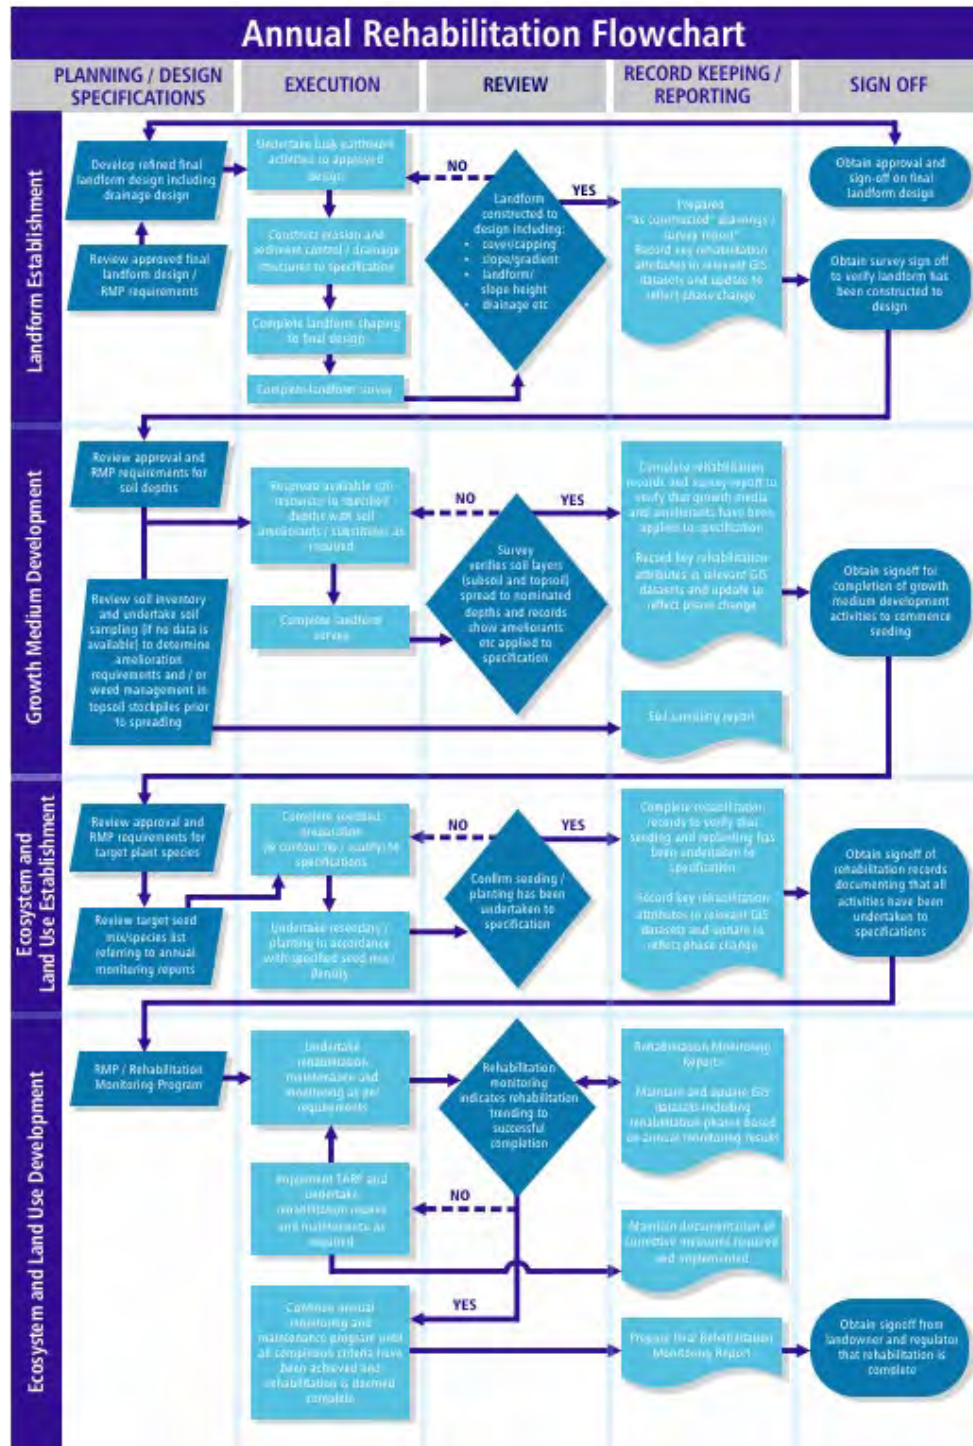
Figure 7-1 Rehabilitation Quality Assurance Process

Whitehaven have developed a Rehabilitation Quality Checklist to be signed off after each phase of rehabilitation prior to proceeding to the next phase (refer **Figure 7-1**).

Whitehaven will implement the RQAP through every phase of rehabilitation to confirm that the rehabilitation strategies outlined in this RMP have been completed in accordance with the nominated methodologies (See **Figure 7-1**). The RQAP will also include inspections and documentation to verify that each phase of demolition and rehabilitation has been completed and has met the completion criteria detailed in **Section 6**. Documentation to be maintained would include (but not limited to):
