Sunnyside Coal Mine Community Consultative Committee Meeting #10

Environmental Monitoring Report March 2011 – May 2011

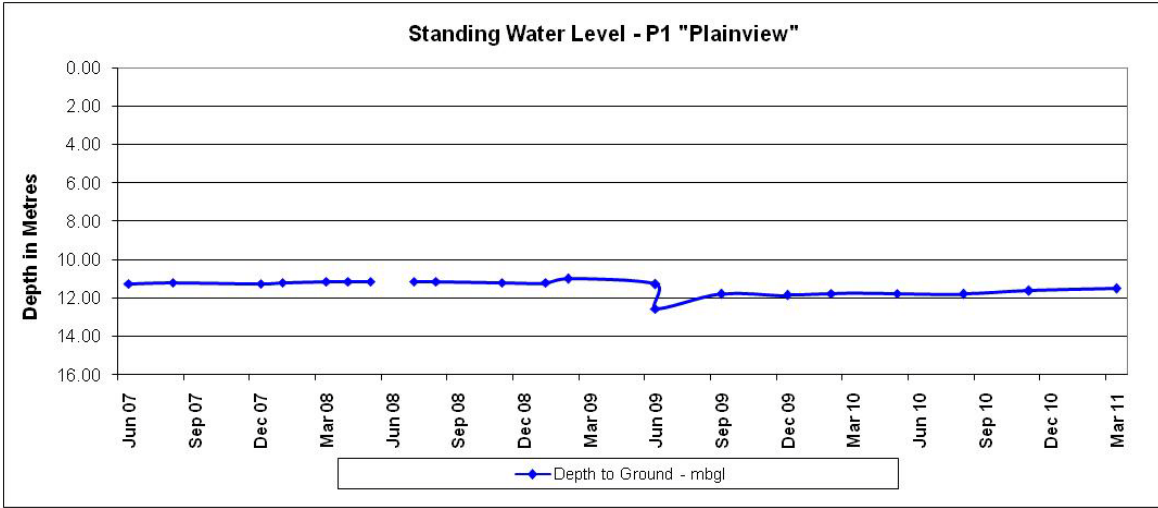
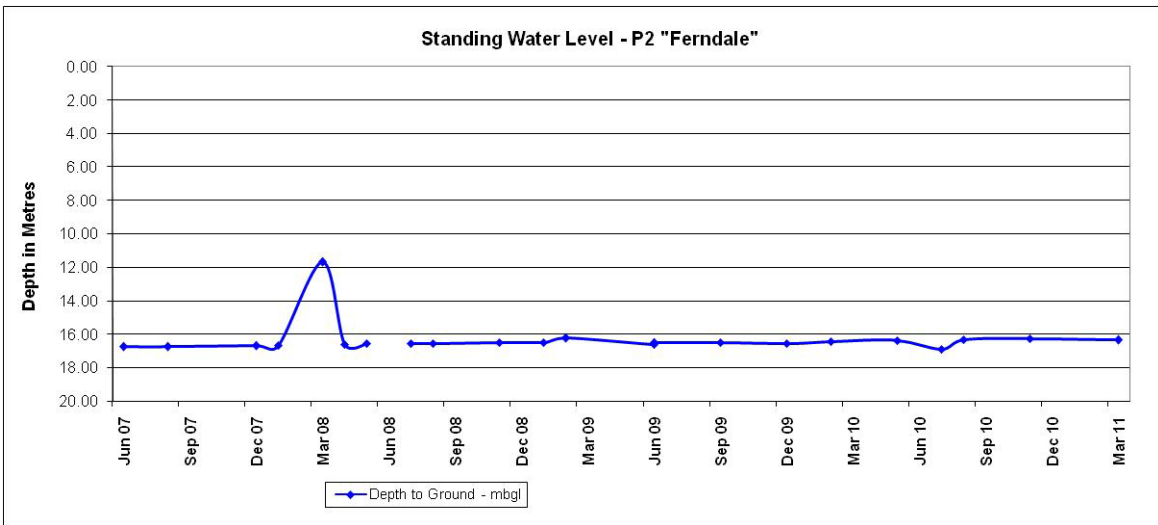
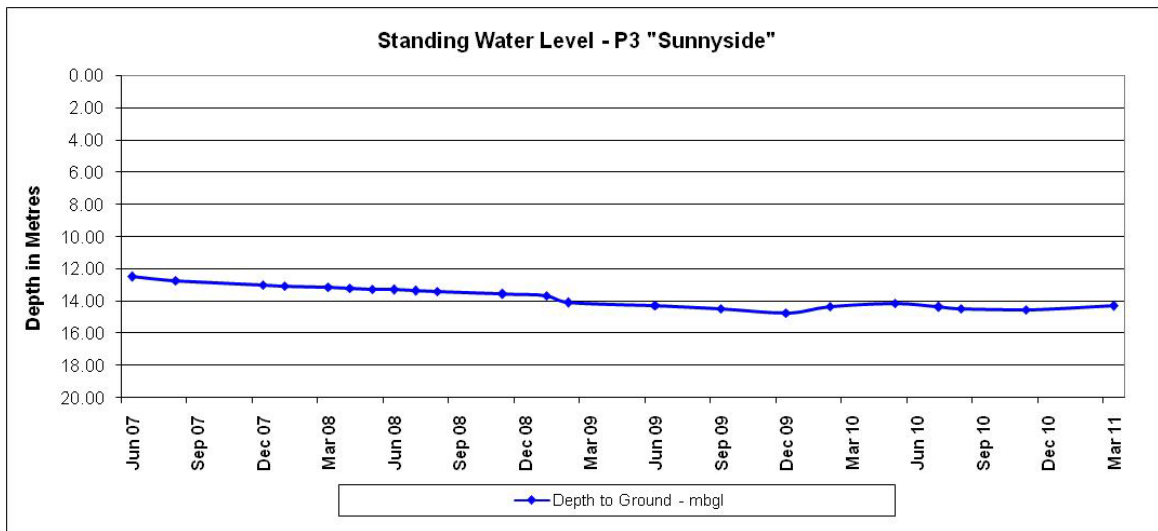
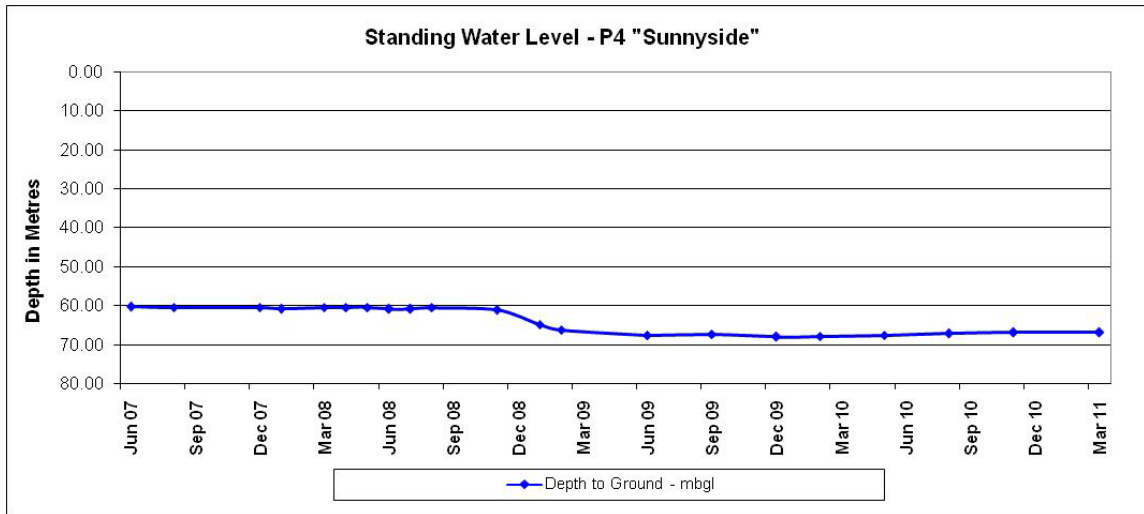
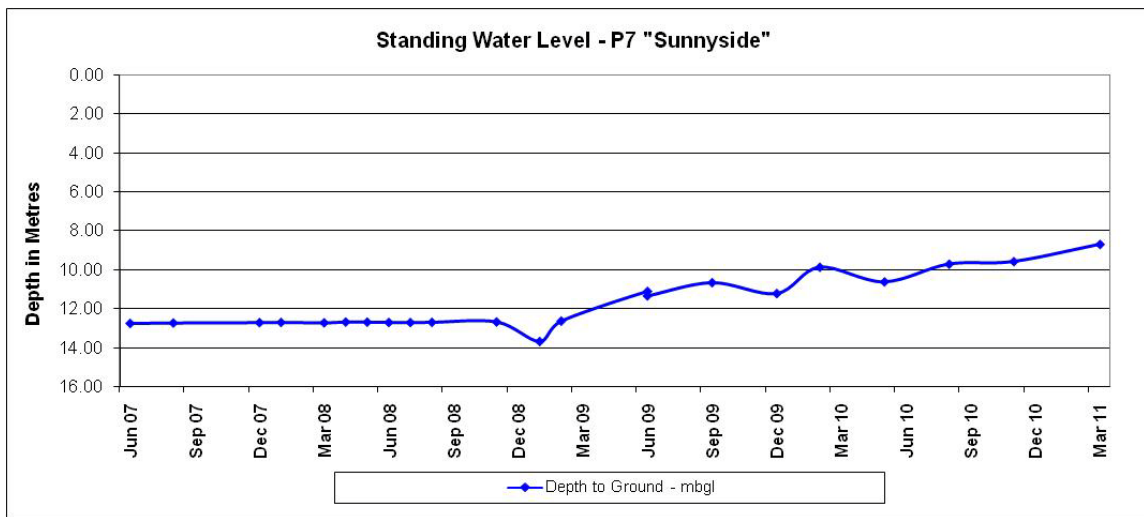
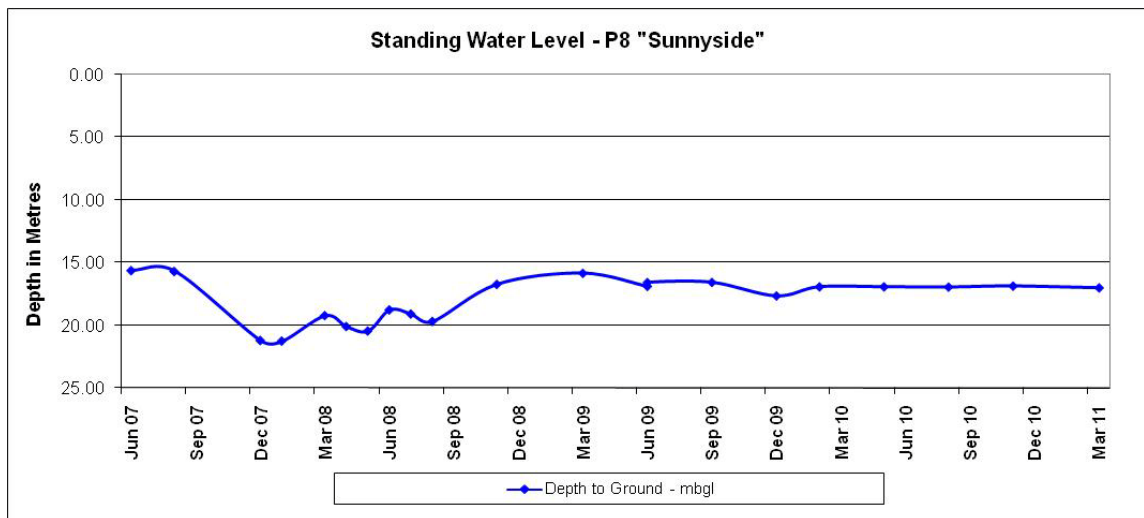
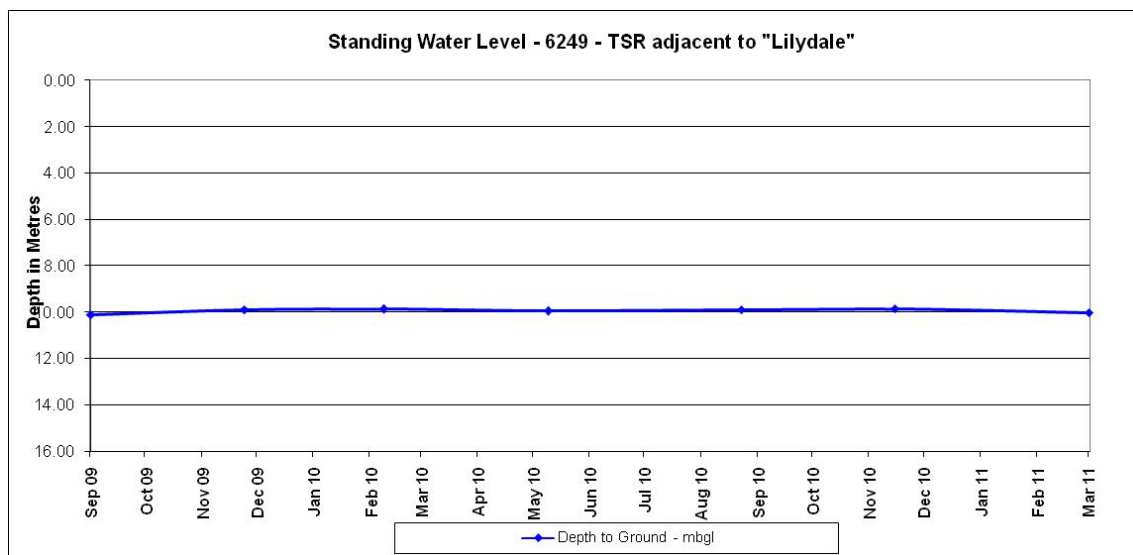
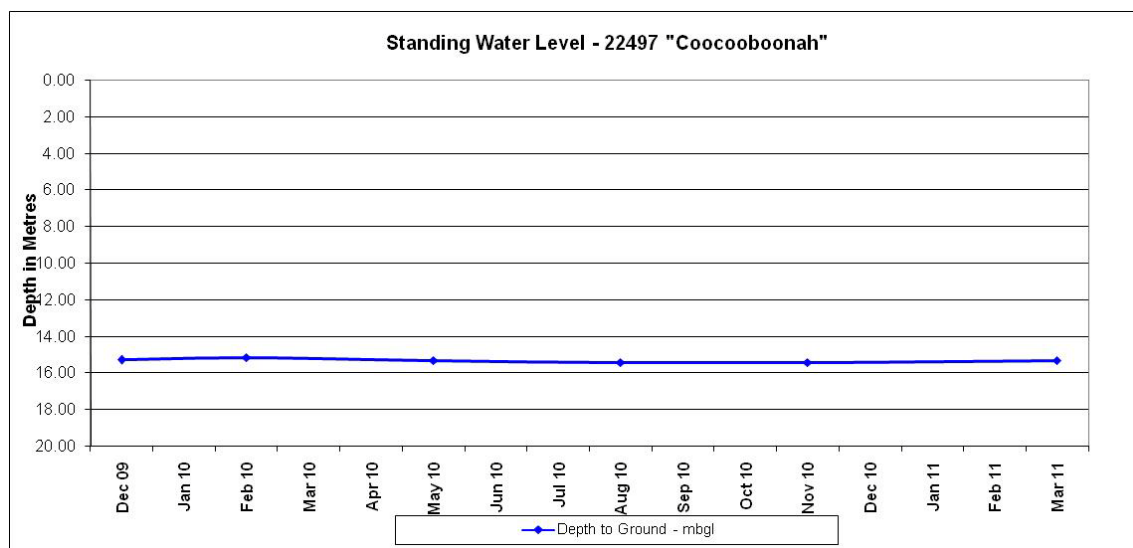
The above results indicate minor variability in groundwater levels with no significant trend applicable. These graphs represent water bores and piezometers which are currently accessible for monitoring.

Groundwater monitoring is undertaken from a range of monitoring piezometers and water bores both within and surrounding the mine site. Standing Water Level (SWL) checks are undertaken on a quarterly basis, with full water quality sampling undertaken on a 6 monthly basis. Monitoring was undertaken on the 8th and 9th March 2011 with results for SWL shown below, with no significant impact/trend indicated from mining operations. The next round of monitoring is expected to be conducted during June 2011.
