WHC-PLN-ROCGLEN REHABILITATION MANAGEMENT PLAN

ROCGLEN MINE REHABILITATION MANAGEMENT PLAN

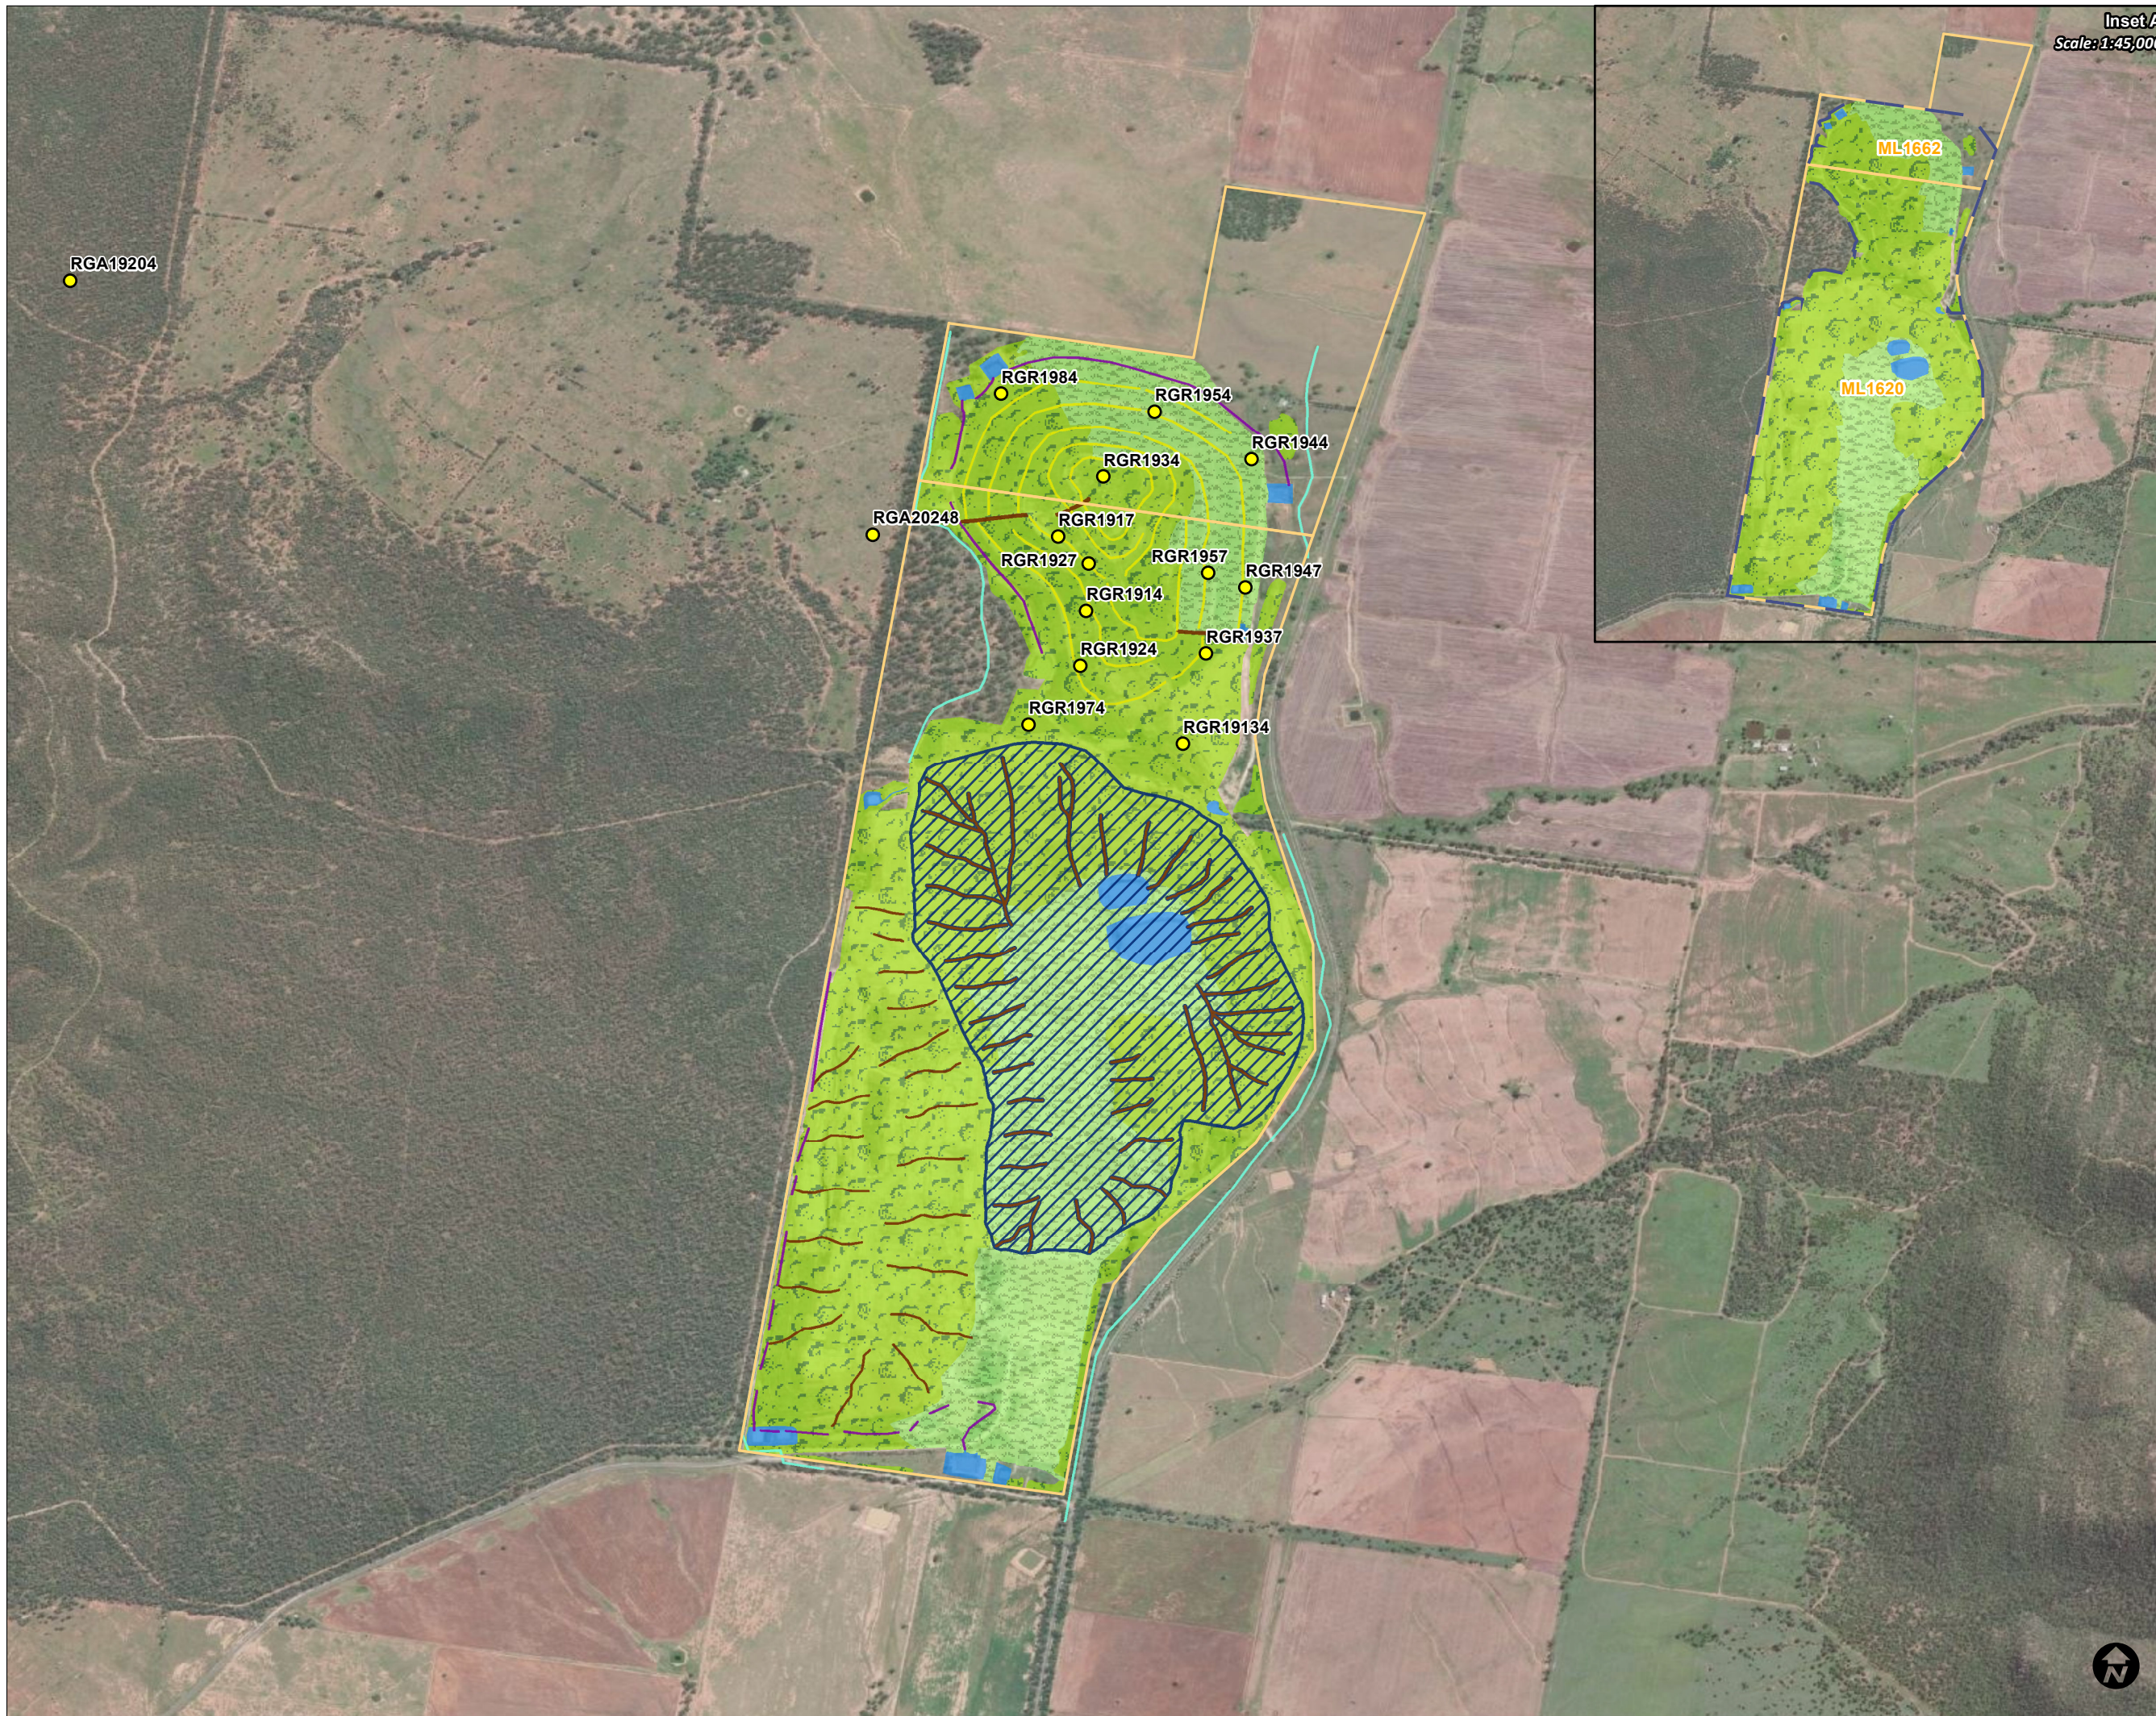
In accordance with the requirements of the Form and Way: Rehabilitation Management Plan for Large Mines (RR, 2021a) a Final Landform and Rehabilitation Plan has been prepared to show the proposed final land use and final landform of Rocglen (refer to **Figure 5-1** and **Figure 5-2**).
