# Tarrowonga Coal Mine Community Consultative Committee Meeting #71

Quarterly Environmental Monitoring Report  
October, 2022 – December, 2022

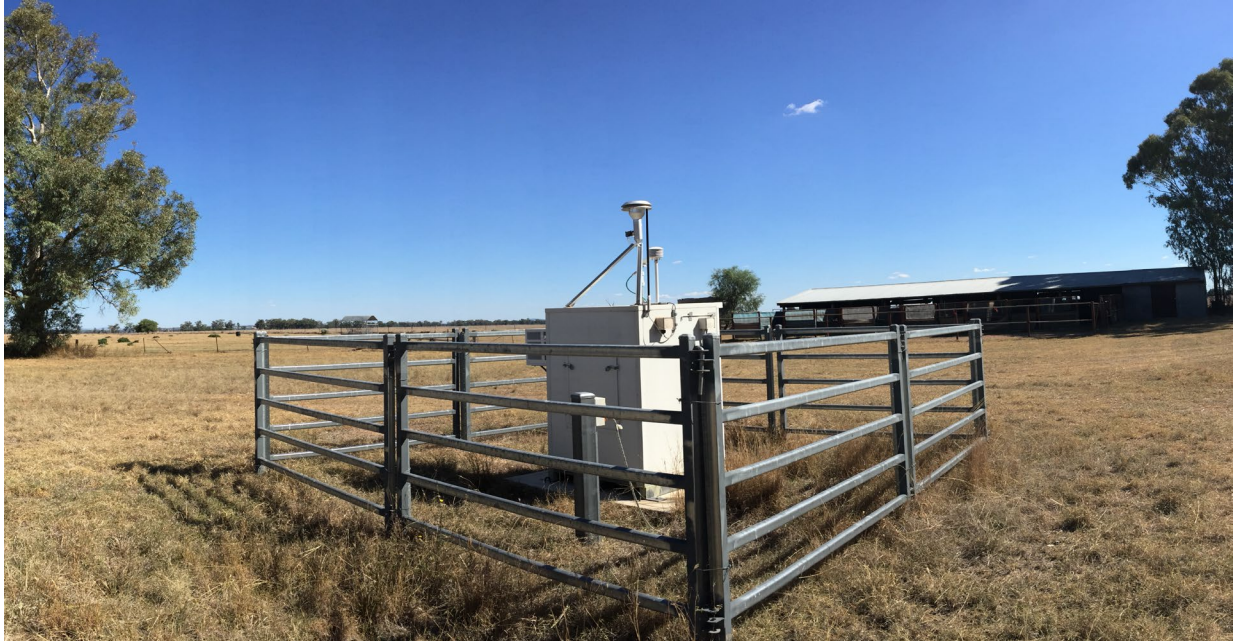
A real time air quality unit (TEOM) is located at the “Flixton” property to monitor PM<sub>10</sub> levels in ambient air, as per the current Air Quality and Greenhouse gas Management Plan. It is an operational management tool and dust levels nearing or reaching the nominated criteria will trigger actions onsite to assess the source of dust and modify operations if it is determined to be related to Tarrawonga operations.

*TEOM installed at Flixton property*

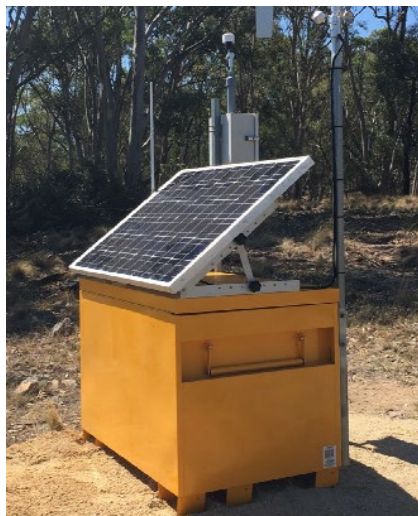
Three portable dust (PM<sub>10</sub>) monitors have been utilised since Nov 2018 to improve the real-time dust monitoring network and assist the operation to mitigate any potential dust generated by the operation.

*Portable and real-time dust monitor installed at TCM in November 2018*

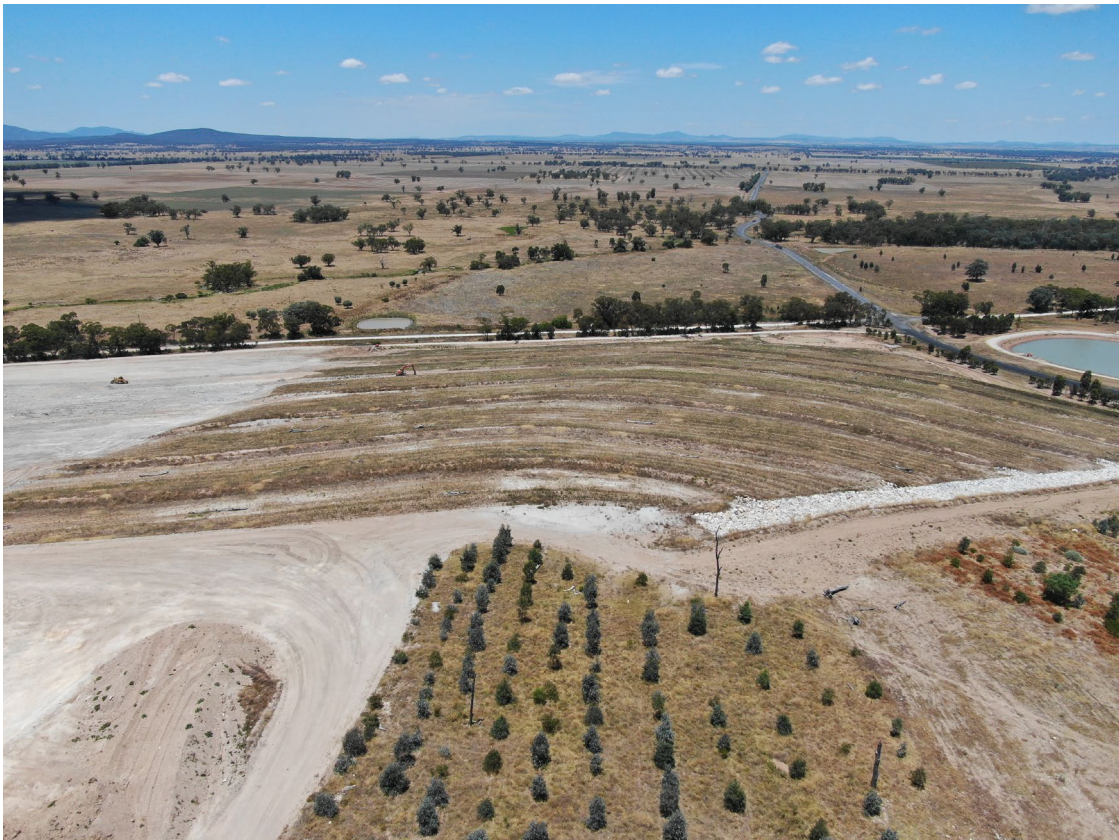
Trees on the SOEA continue to successfully establish and grow on our rehabilitation area, as can be seen on the image below.

*Figure 1: Photo taken in January 2023 from the Southern Emplacement Area rehabilitated in 2022.*

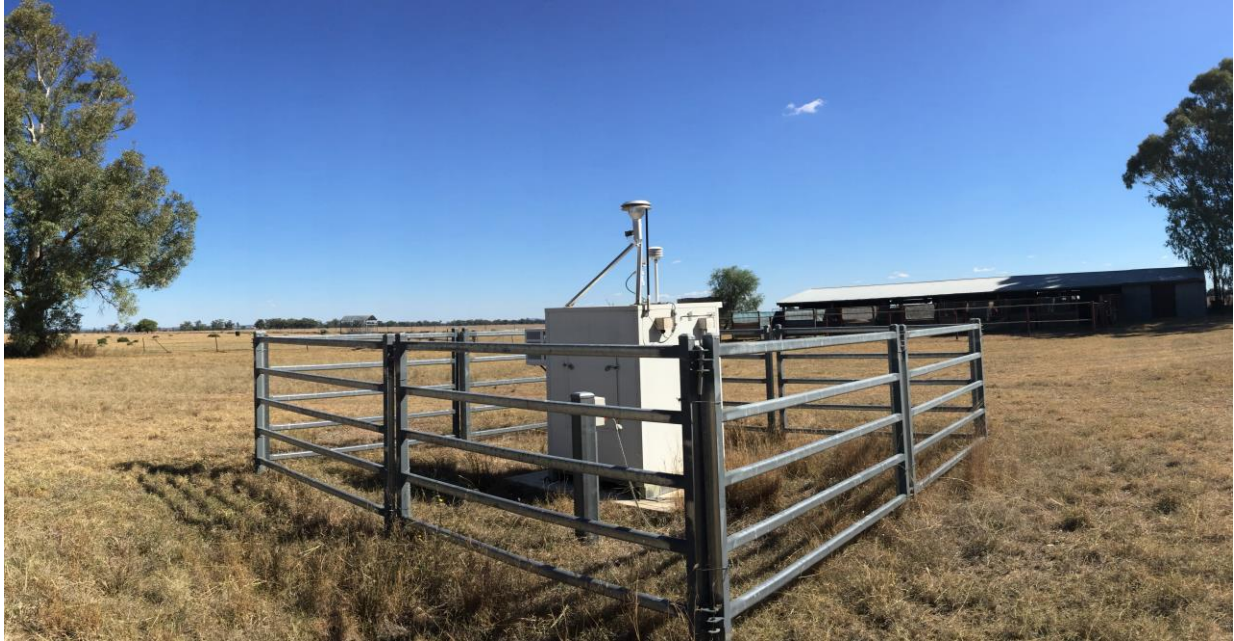
A real time air quality unit (TEOM) is located at the “Flixton” property to monitor PM<sub>10</sub> levels in ambient air, as per the current Air Quality and Greenhouse gas Management Plan. It is an operational management tool and dust levels nearing or reaching the nominated criteria will trigger actions onsite to assess the source of dust and modify operations if it is determined to be related to Tarrawonga operations.

*TEOM installed at Flixton property*

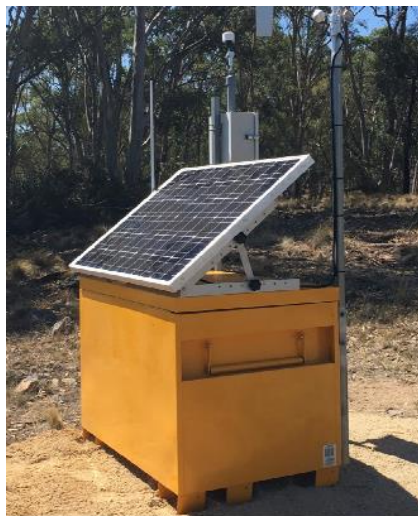
Three portable dust (PM<sub>10</sub>) monitors have been utilised since Nov 2018 to improve the real-time dust monitoring network and assist the operation to mitigate any potential dust generated by the operation.

*Portable and real-time dust monitor installed at TCM in November 2018*

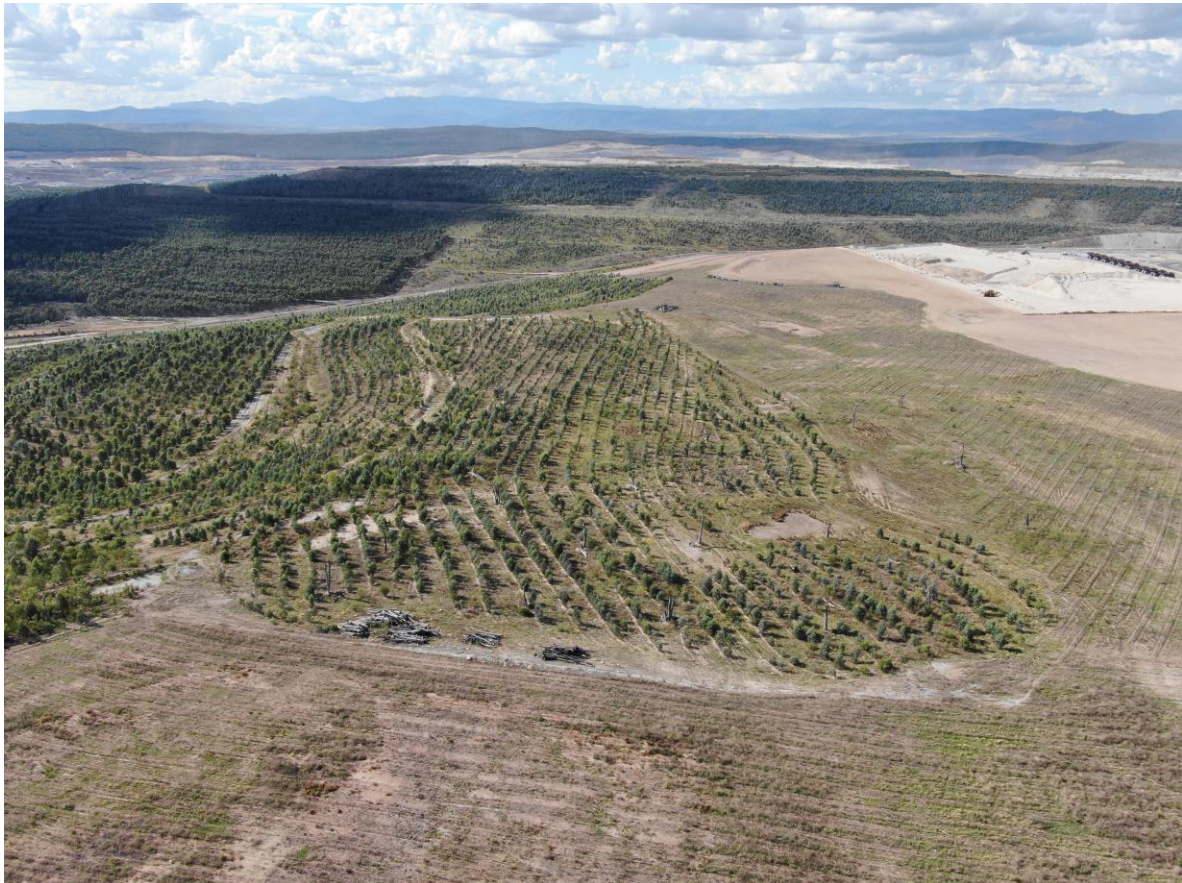
Trees on the NEA continue to successfully establish and grow on our rehabilitation area, as can be seen on the image below.

*Figure 1: Photo taken in March 2023 of our Northern Emplacement Area*

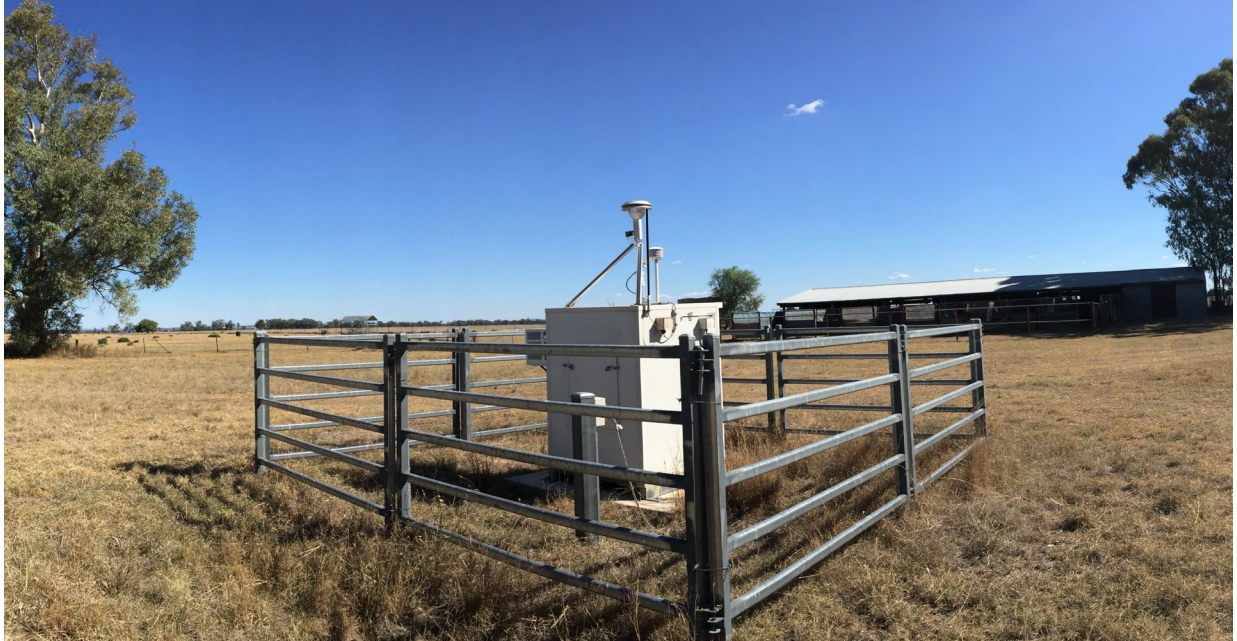
A real time air quality unit (TEOM) is located at the “Flixton” property to monitor PM<sub>10</sub> levels in ambient air, as per the current Air Quality and Greenhouse gas Management Plan. It is an operational management tool and dust levels nearing or reaching the nominated criteria will trigger actions onsite to assess the source of dust and modify operations if it is determined to be related to Tarrawonga operations.

*Figure 1: TEOM installed at Flixton property*

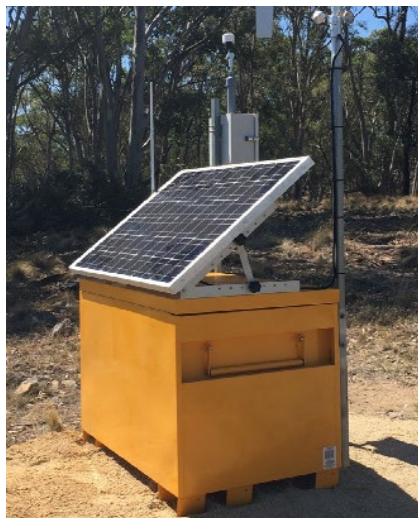
Three portable dust (PM<sub>10</sub>) monitors have been utilised since Nov 2018 to improve the real-time dust monitoring network and assist the operation to mitigate any potential dust generated by the operation.

*Figure 2: Portable and real-time dust monitor installed at TCM in November 2018*

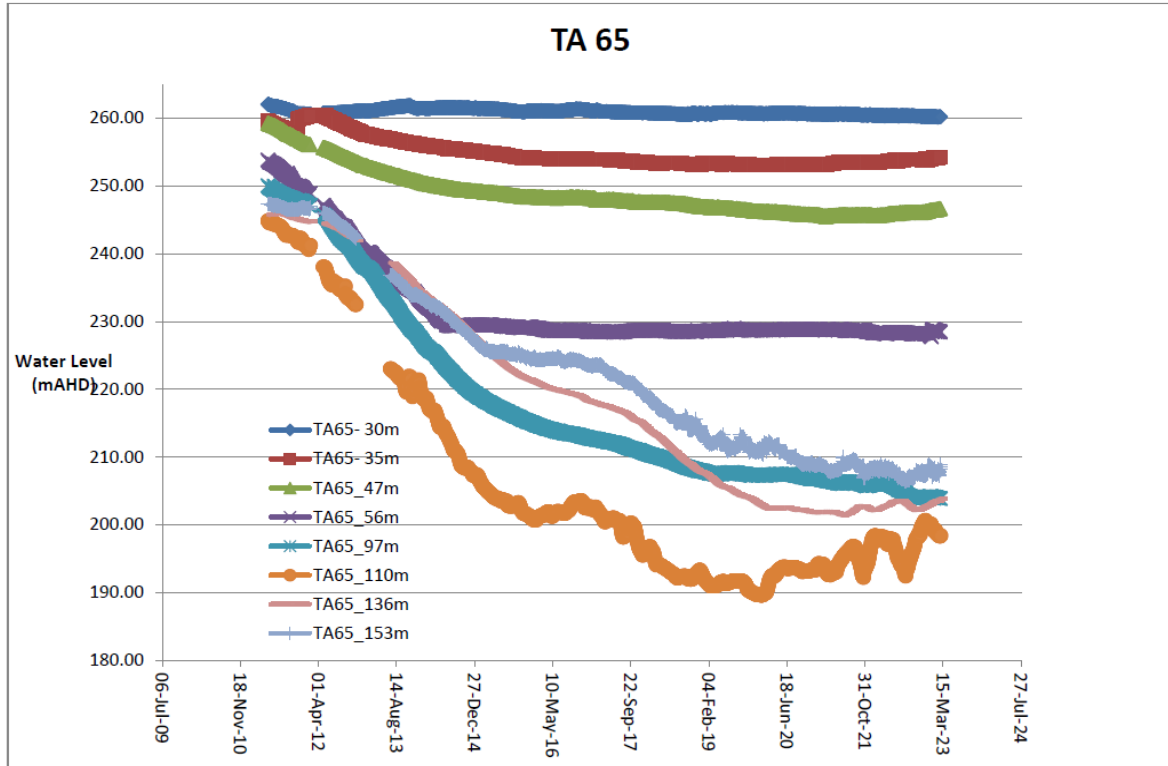
The Vibrating Wire Piezometer, located in the North-East of Tarrawonga’s Mining Lease, is monitored as per our Project Approval. The graph below (Figure 3) displays the water level at differing depths within the VWP.

Figure 3: Groundwater Levels at TA65 (VWP)

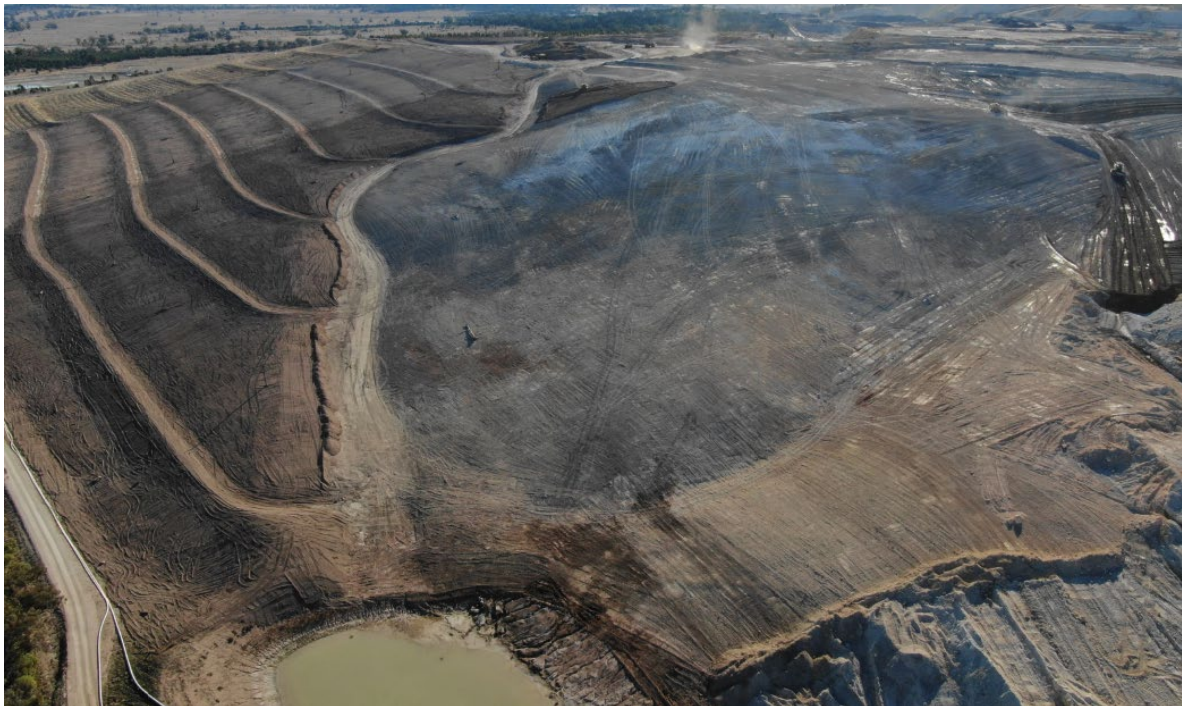
Trees on the NEA continue to successfully establish and grow on our rehabilitation area.

*Figure 4: Photo taken July 31 2023 of our Southern Emplacement Area rehabilitation progression.*

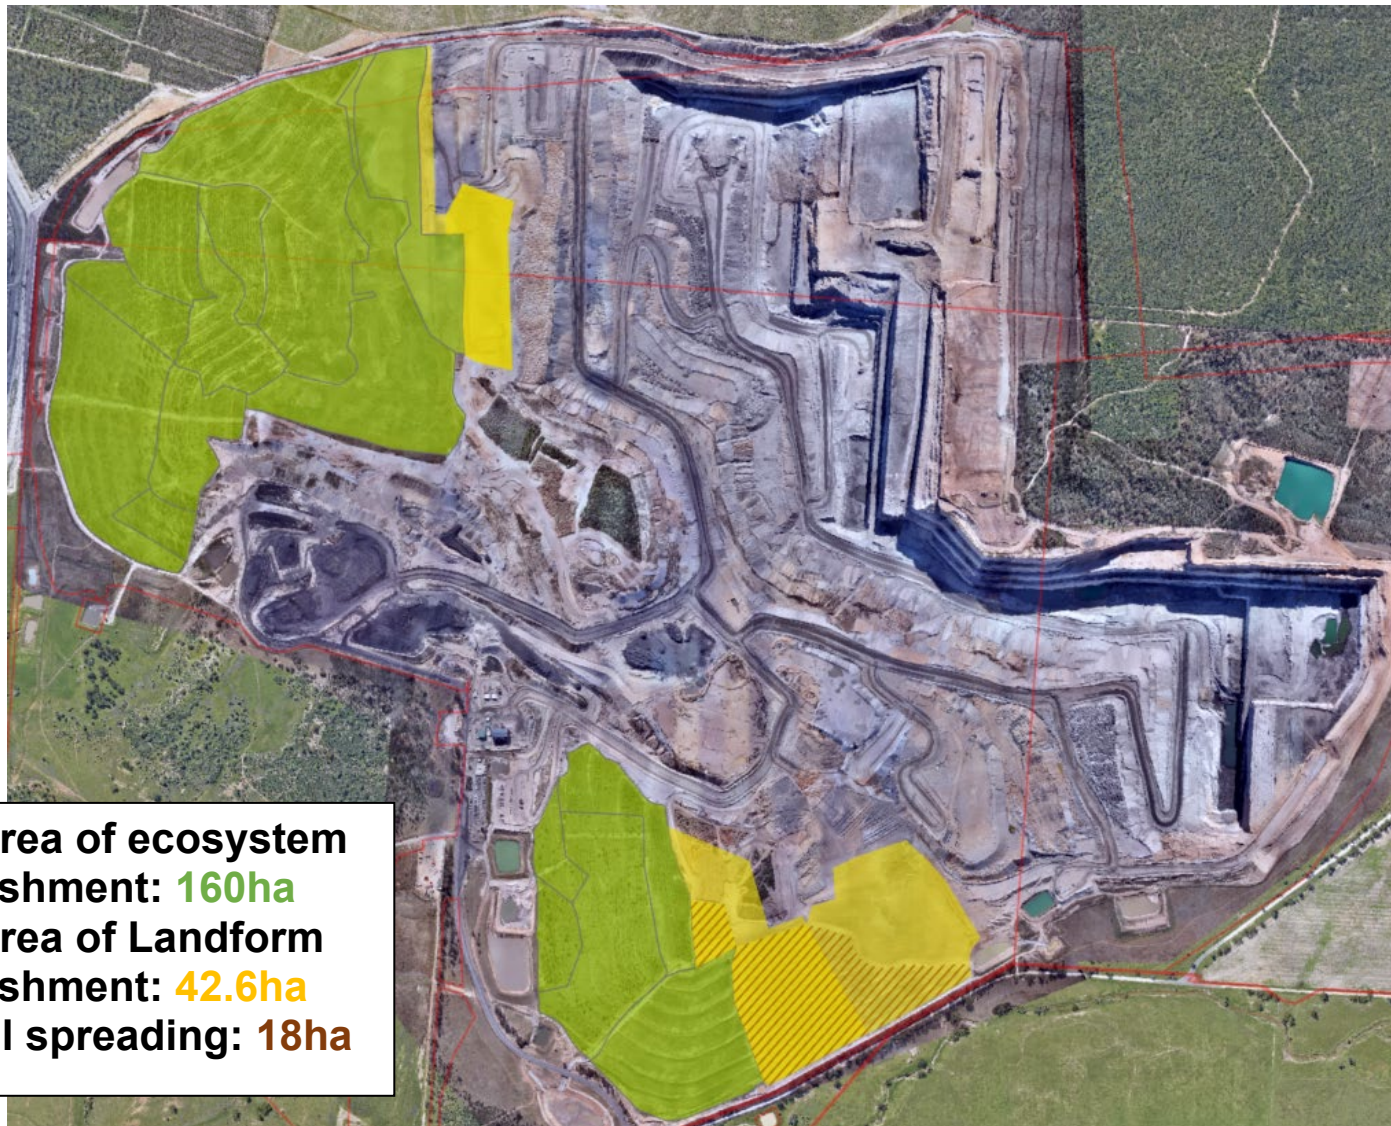
Figure 5: Rehab Status as at end of July 2023

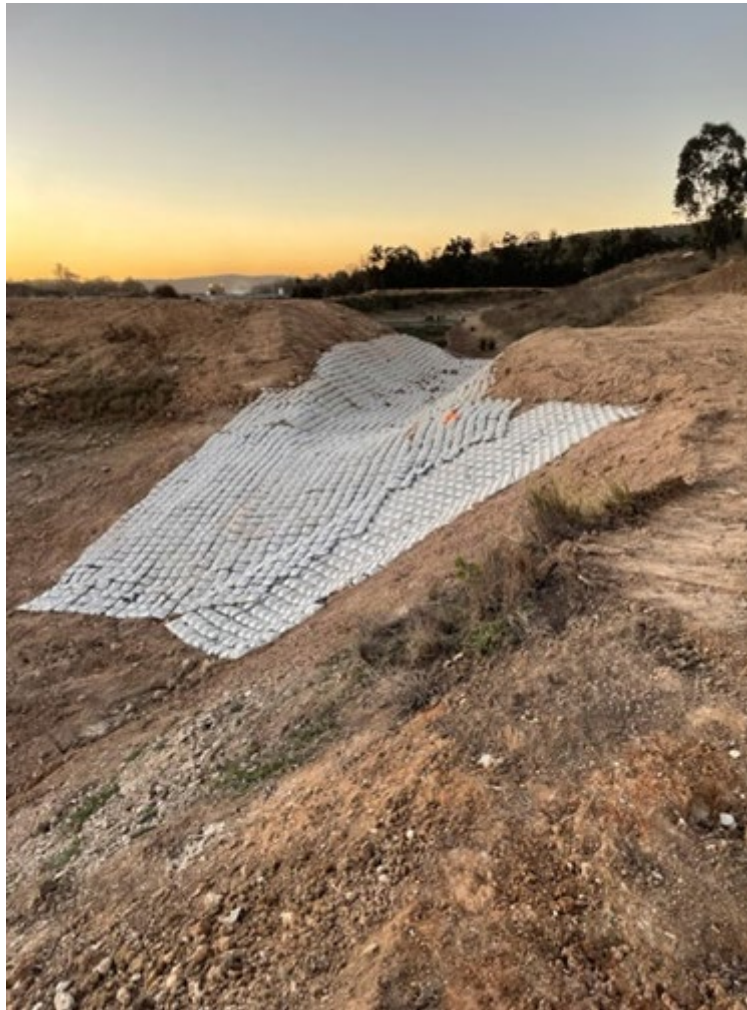
The updated EPL variation was issued by the EPA in June 2023. This variation outlines recommended improvements to some of Tarrawongas sediment dam inlets and outlets, and some require the use of Earthlok (a rock lining mat). Some of these projects have already been completed as can be seen in the photo below.

*Figure 6: Earthlok installation on the inlet of SD17 (LDP 1)*

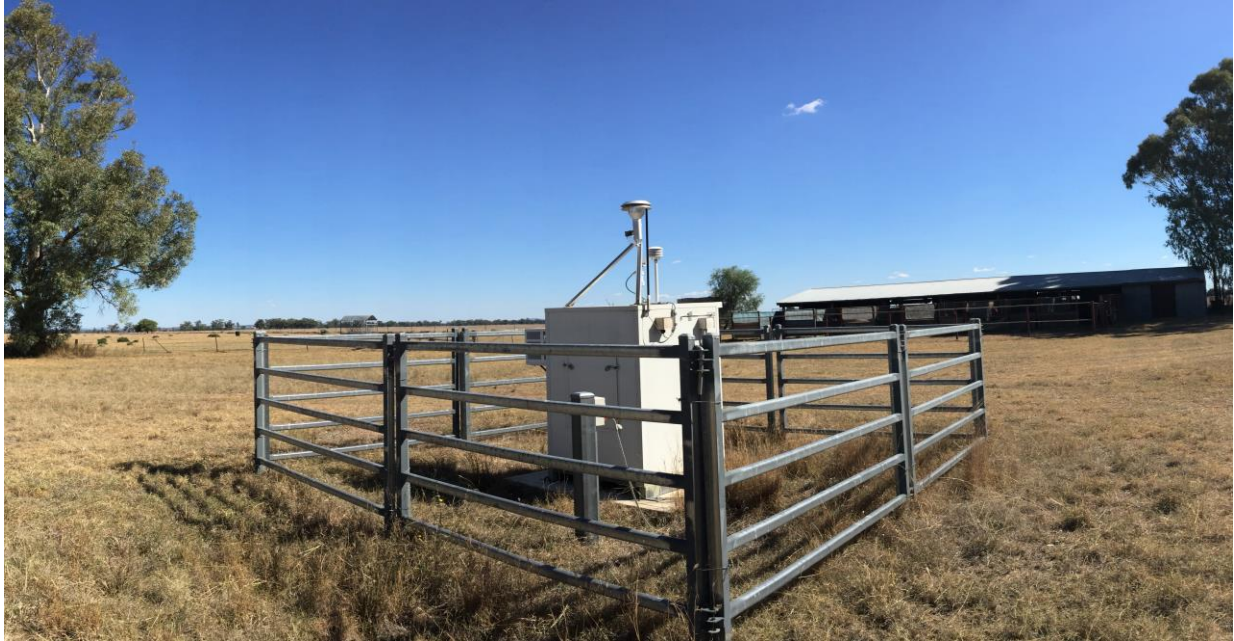
A real time air quality unit (TEOM) is located at the “Flixton” property to monitor PM<sub>10</sub> levels in ambient air, as per the current Air Quality and Greenhouse gas Management Plan. It is an operational management tool and dust levels nearing or reaching the nominated criteria will trigger actions onsite to assess the source of dust and modify operations if it is determined to be related to Tarrawonga operations.

*Figure 1: TEOM installed at Flixton property*

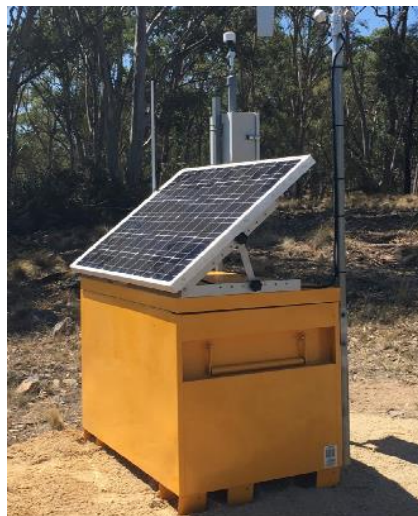
Three portable dust (PM<sub>10</sub>) monitors have been utilised since Nov 2018 to improve the real-time dust monitoring network and assist the operation to mitigate any potential dust generated by the operation.

*Figure 2: Portable and real-time dust monitor installed at TCM in November 2018*

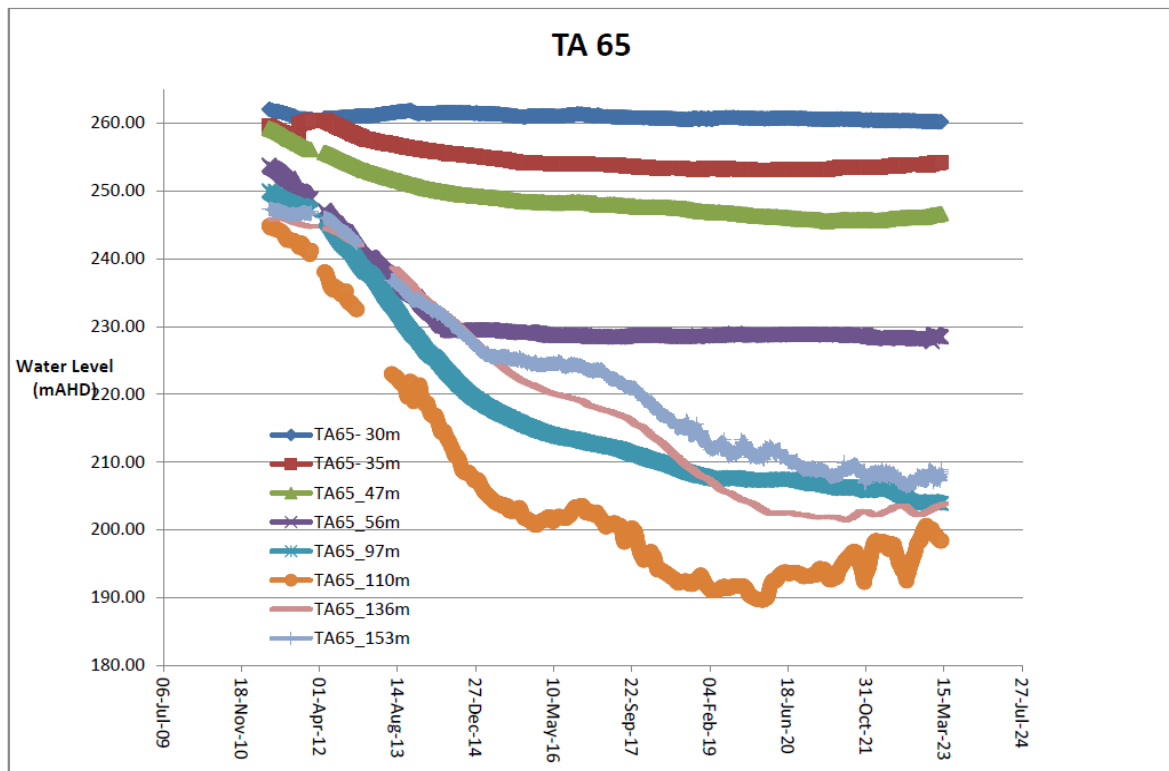
The Vibrating Wire Piezometer, located in the North-East of Tarrawonga’s Mining Lease, is monitored as per our Project Approval. The graph below (Figure 3) displays the water level at differing depths within the VWP.

Figure 3: Groundwater Levels at TA65 (VWP)

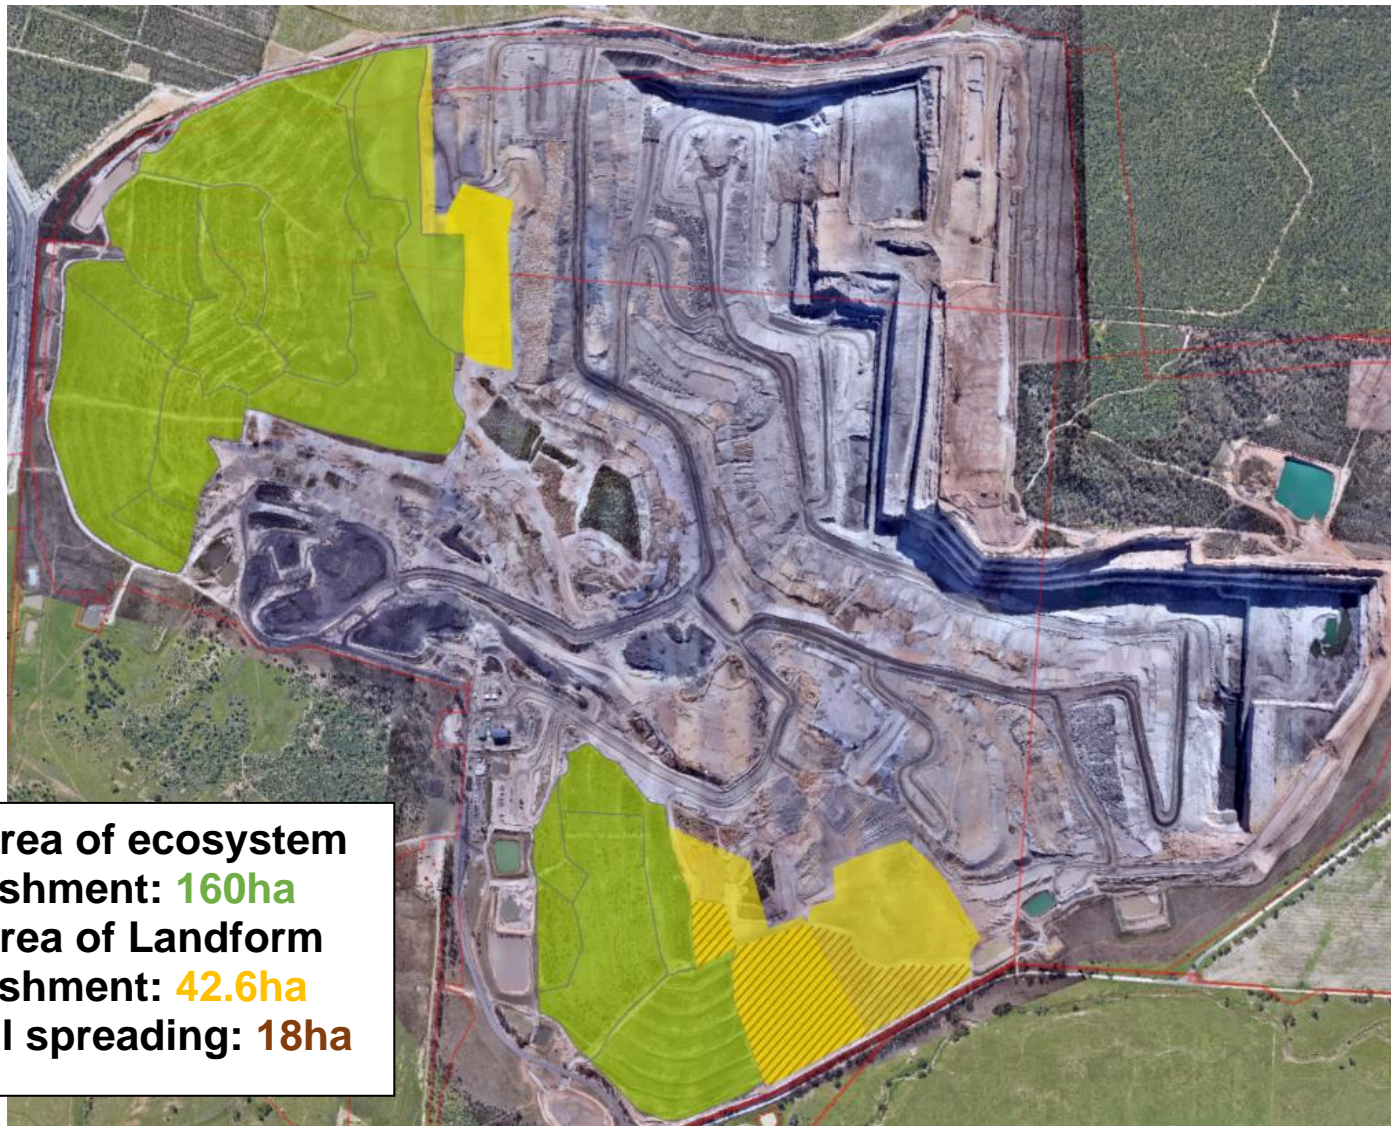
Trees on the both the North and South rehab areas continue to successfully establish and grow on our rehabilitation area. Ecologists were here last week to assess the success rate of rehab and that monitoring report will be included in our Annual Review.

**Total area of ecosystem establishment: 160ha**  
**Total area of Landform establishment: 42.6ha**  
**Topsoil spreading: 18ha**

Figure 4: Rehab Status as at end of September 2023

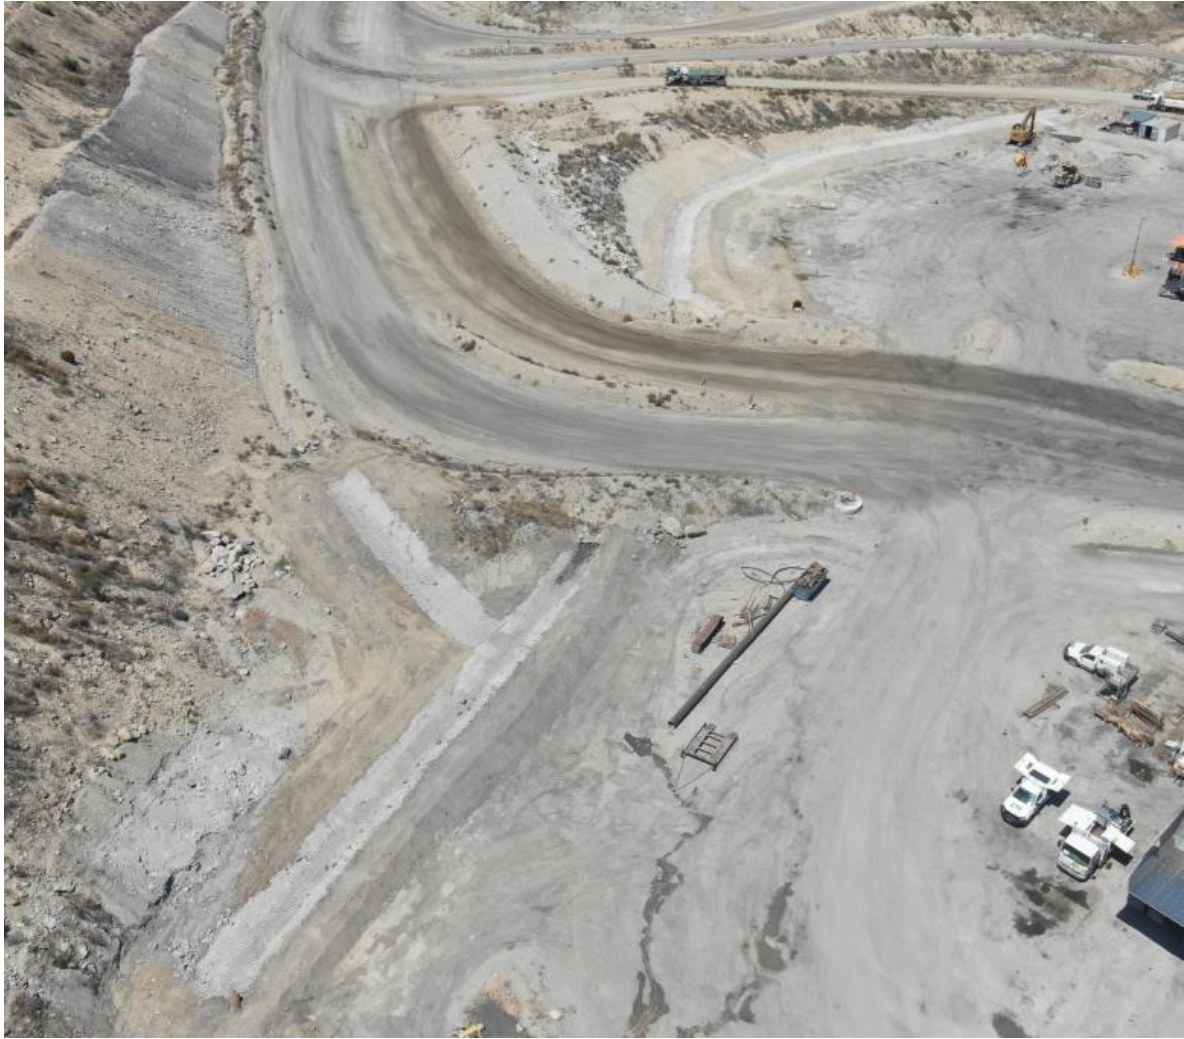
The updated EPL variation was issued by the EPA in June 2023. This variation outlines recommended improvements to some of Tarrawongas sediment dam inlets, outlets and drains, and some require the use of Earthlok (a rock lining mat). Some of these projects have already been completed as can be seen in the photo below.

*Figure 5: Earthlok installation on the drain from the ROM pad to SB16A*
